**Flood Control Project Maintenance  
Levee Inspections**

**Fall 2018 Levee Maintenance Deficiency Summary Report**

**Flood Control Project Maintenance  
Levee Inspections****LMA District Cover Sheet  
Fall 2018 Levee Inspection Results****Reclamation District No. 2103 Wheatland Vicinity**

**Reclamation District No. 2103 Wheatland Vicinity**

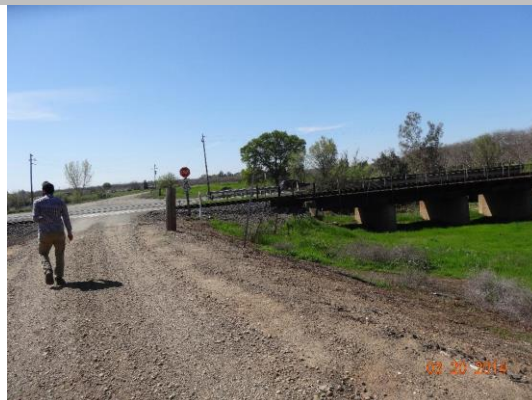
Photo 2 of 3 : UCIP\_FA\_2018\_39987\_71884.jpg

LM Start	<b>0.56</b>	Rating **	M	Issue No.	<b>32 (cont)</b>
LM End	<b>0.56</b>	Issue Type +	En	Location *

View of levee crown and waterward side.

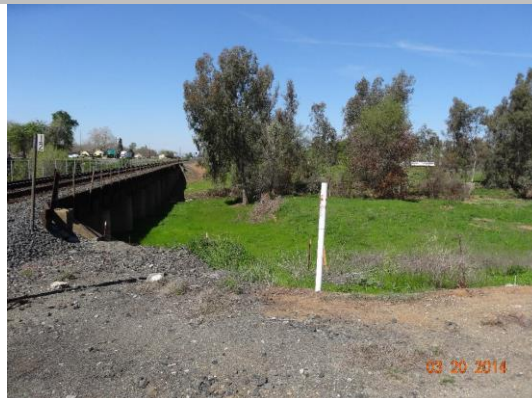
Photo 3 of 3 : UCIP\_FA\_2018\_39987\_71886.jpg

LM Start	0.56	Rating **	M	Issue No.	32 (cont)	
LM End	0.56	Issue Type +	En	Location *		
Category	Supplemental			GPS Latitude/Longitude		
				Start	End	
Item	DWR UCIP Field Study			39.022665 °	39.022665 °	
				-121.444688 °	-121.444688 °	
DWR ID	24879					
Comment Code						
Inspector Comment						
FS_ID:39987 DS_ID:24879 EP_NO: N/A Repair Type: Non-Urgent Crossing Status: Indicator Found UCIP Comments: 03/04/2014 Need to contact owner to obtain depth of line through levee. Also need permit authorizing conduit through levee. (O. Magana - DWR UCIP) FIELD_STRUCT_DESC: Conduit line through levee. Markers visible on both sides. FS Date: 3/4/2014

View of waterward side.

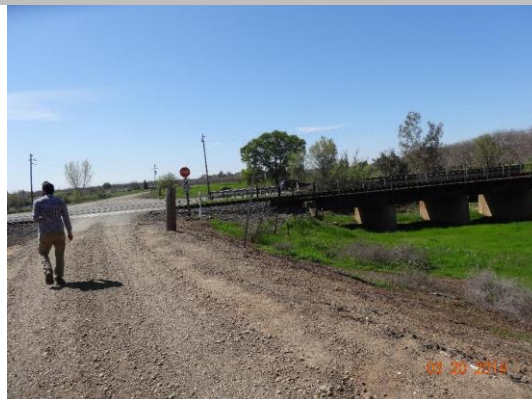
Photo 1 of 3 : UCIP\_FA\_2018\_38323\_69860.jpg

LM Start	0.56	Rating **	M	Issue No.	33	
LM End	0.56	Issue Type +	En	Location *		
Category	Supplemental			GPS Latitude/Longitude		
				Start		End
Item	DWR UCIP Field Study			39.022733 °		39.022733 °
				-121.444626 °		-121.444626 °
DWR ID	19469

Comment Code						
Inspector Comment						
FS_ID:38323 DS_ID:19469 EP_NO: 2098 Repair Type: Non-Urgent Crossing Status: Indicator Found UCIP Comments: 03/20/2014 Need to contact owner to determine status of crossing. Need date of last inspection and confirmation that crossing is still in operable condition. (O. Magana - DWR UCIP) FIELD_STRUCT_DESC: 16-inch steel gas line through the levee, 3 feet below the crown. Marker on waterside (WS) slope. (16-inch line authorized under Permit No. 2098, 1955-Pacific Gas and Electric Company [PG&E]). [Additional Reference(s): DWR Levee Logs, 2005. USACE Sacramento O&M Manual Unit No. 146, November 1962, (HLM 0.56)] FS Date: 3/20/2014

View of levee crown at crossing.

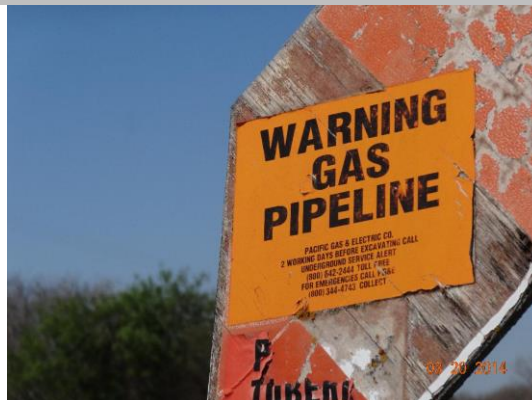
Photo 3 of 3 : UCIP\_FA\_2018\_38323\_69858.jpg

Comment Code						
Inspector Comment						
FS_ID:38323 DS_ID:19469 EP_NO: 2098 Repair Type: Non-Urgent Crossing Status: Indicator Found UCIP Comments: 03/20/2014 Need to contact owner to determine status of crossing. Need date of last inspection and confirmation that crossing is still in operable condition. (O. Magana - DWR UCIP) FIELD_STRUCT_DESC: 16-inch steel gas line through the levee, 3 feet below the crown. Marker on waterside (WS) slope. (16-inch line authorized under Permit No. 2098, 1955-Pacific Gas and Electric Company [PG&E]). [Additional Reference(s): DWR Levee Logs, 2005. USACE Sacramento O&M Manual Unit No. 146, November 1962, (HLM 0.56)] FS Date: 3/20/2014

Contact information of owner.

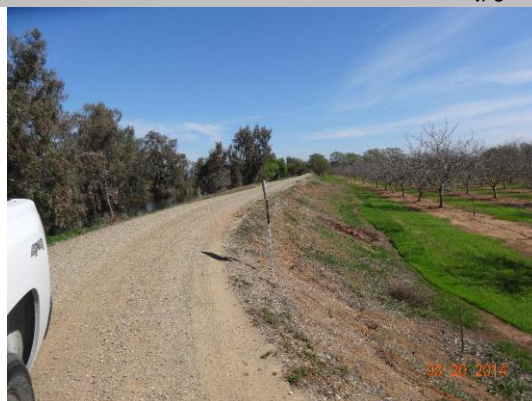
Photo 1 of 3 : UCIP\_FA\_2018\_38324\_69864.jpg

Comment Code					
Inspector Comment					
FS_ID:38324 DS_ID:19470 EP_NO: 789 Repair Type: Non-Urgent Crossing Status: Indicator Found UCIP Comments: 03/20/2014 Need to contact owner to determine status of crossing. Need date of last inspection and confirmation that crossing is still in operable condition. (O. Magana - DWR UCIP) FIELD_STRUCT_DESC: 16-inch steel gas line through levee, 3 feet below the crown. Concrete inspection chamber (24-inch by 18-inch box with 4-inch walls) on the waterside (WS) shoulder, covered with dirt. Gas line marker on landside (LS) slope. Extends underneath Dry Creek channel, covered with concrete slab approximately 18-inches wide. (8.625-inch gas line authorized under Permit No. 789, 1939-Pacific Gas and Electric Company [PG&E]). [Additional Reference(s): DWR Levee Logs, 2005, 16-inch gas line. USACE Sacramento O&M Manual Unit No. 146, November 1962, (HLM 0.63), 16-inch gas line] FS Date: 3/20/2014

View of levee crown looking upstream.

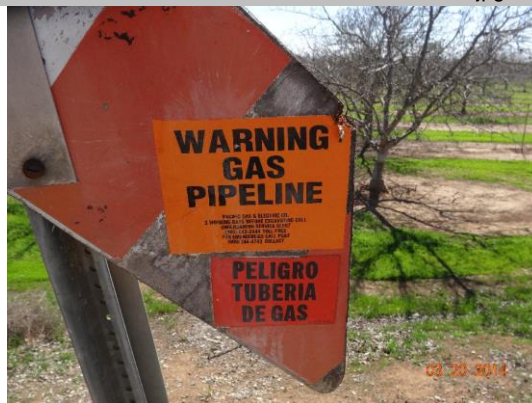
Photo 2 of 3 : UCIP\_FA\_2018\_38324\_69863.jpg

Contact information for gas pipeline.

Comment Code						
Inspector Comment						
FS_ID:38324 DS_ID:19470 EP_NO: 789 Repair Type: Non-Urgent Crossing Status: Indicator Found UCIP Comments: 03/20/2014 Need to contact owner to determine status of crossing. Need date of last inspection and confirmation that crossing is still in operable condition. (O. Magana - DWR UCIP) FIELD_STRUCT_DESC: 16-inch steel gas line through levee, 3 feet below the crown. Concrete inspection chamber (24-inch by 18-inch box with 4-inch walls) on the waterside (WS) shoulder, covered with dirt. Gas line marker on landside (LS) slope. Extends underneath Dry Creek channel, covered with concrete slab approximately 18-inches wide. (8.625-inch gas line authorized under Permit No. 789, 1939-Pacific Gas and Electric Company [PG&E]). [Additional Reference(s): DWR Levee Logs, 2005, 16-inch gas line. USACE Sacramento O&M Manual Unit No. 146, November 1962, (HLM 0.63), 16-inch gas line] FS Date: 3/20/2014

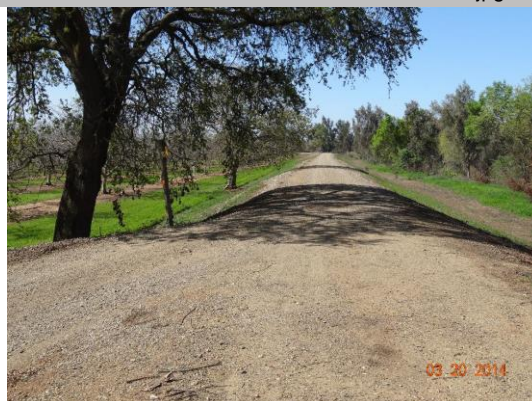
Photo 3 of 3 : UCIP\_FA\_2018\_39988\_71888.jpg

LM Start	0.81	Rating **	M	Issue No.	35 (cont)	
LM End	0.81	Issue Type +	En	Location *		
Category	Supplemental			GPS Latitude/Longitude		
				Start	End	
Item	DWR UCIP Field Study			39.024725 °	39.024725 °	
				-121.440978 °	-121.440978 °	
DWR ID	24880					
Comment Code						
Inspector Comment						
FS_ID:39988						
DS_ID:24880						
EP_NO: N/A						
Repair Type: Non-Urgent						
Crossing Status: Indicator Found						
UCIP Comments: 03/04/2014 No marker found on waterward side-- need to confirm with owner if crossing goes through levee. If so, need depth of crossing through levee. Also need to obtain permit number used to authorize crossing. (O. Magana - DWR UCIP)						
FIELD_STRUCT_DESC: Conduit line through levee of unknown material or depth below the crown. Marker visible on landside (LS).						
FS Date: 3/4/2014

View of levee at crossing.

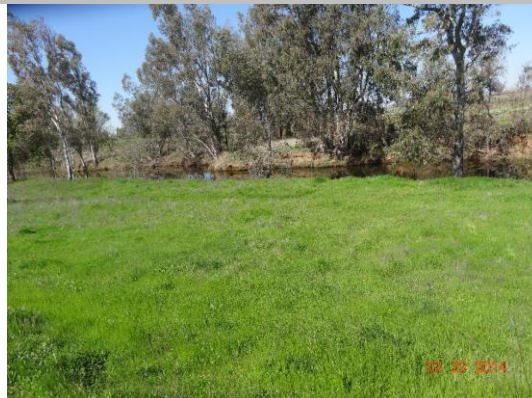
Photo 2 of 3 : UCIP\_FA\_2018\_41183\_69916.jpg

Comment Code						
Inspector Comment						
FS_ID:41183 DS_ID:19473 EP_NO: 1886 Repair Type: Non-Urgent Crossing Status: Indicator Found UCIP Comments: 03/20/2014 Need to coordinate with owner. Severely corroded section of steel pipe present on waterward side--no other evidense present at this location. Owner will need to coordinate with CVFPB and DWR-Inspector to determine proper action to abandon crossing. (O. Magana - DWR UCIP) FIELD_STRUCT_DESC: *ABANDONED* 12-inch steel irrigation pipe through the levee, 3.1 feet below the crown. Siphon breaker on the waterward slope. Concrete standpipe at the landward toe. Vertical pump on waterside (WS). Open on WS end. Permit includes gravel dam through channel of Dry Creek. Crossing is angled 45 degrees. (10-inch pipe authorized under Permit No. 1886, 1959-R. H. Blackford, Jr.) [Additional Reference(s): DWR Levee Logs, 2005. USACE Sacramento O&M Manual Unit No. 146, November 1962, (HLM 1.86)] FS Date: 3/20/2014

View of waterward side.

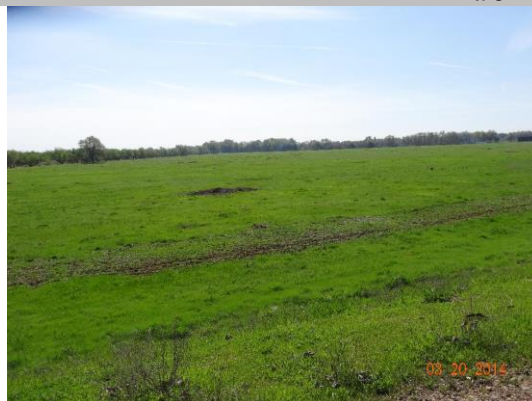
Photo 3 of 3 : UCIP\_FA\_2018\_41183\_69915.jpg

View of landward side.

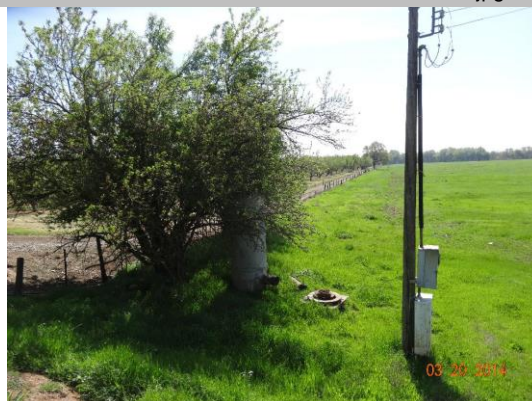
Photo 1 of 3 : UCIP\_FA\_2018\_38327\_69881.jpg

LM Start	1.86	Rating **	M	Issue No.	38	
LM End	1.86	Issue Type +	En	Location *		
Category	Supplemental			GPS Latitude/Longitude		
				Start	End	
Item	DWR UCIP Field Study			39.029694 °	39.029694 °	
				-121.423946 °	-121.423946 °	
DWR ID	19512					
Comment Code						
Inspector Comment						
FS_ID:38327 DS_ID:19512 EP_NO: N/A Repair Type: Non-Urgent Crossing Status: Indicator Found UCIP Comments: 03/20/2014 Unable to determine if there is a crossing through pipe. Will need to coordinate with owner to determine additional information about appurtenances found on landward side. (O. Magana - DWR UCIP) FIELD_STRUCT_DESC: Irrigation pump, service pole, and 36-inch concrete standpipe, 5 feet from the landside (LS) toe. No pump was found during field visit 3/20/14. [Additional Reference(s): DWR Levee Logs, 2005] FS Date: 3/20/2014

View of landward side.

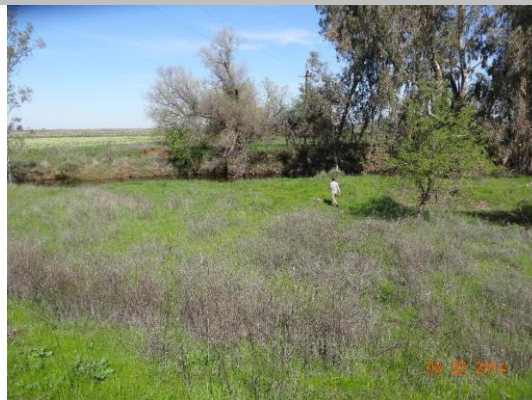
Photo 2 of 3 : UCIP\_FA\_2018\_38327\_69880.jpg

View of waterward side.

LM Start	1.86	Rating **	M	Issue No.	38 (cont)	
LM End	1.86	Issue Type +	En	Location *		
Category	Supplemental			GPS Latitude/Longitude		
				Start	End	
Item	DWR UCIP Field Study			39.029694 °	39.029694 °	
				-121.423946 °	-121.423946 °	
DWR ID	19512					
Comment Code						
Inspector Comment						
FS_ID:38327 DS_ID:19512 EP_NO: N/A Repair Type: Non-Urgent Crossing Status: Indicator Found UCIP Comments: 03/20/2014 Unable to determine if there is a crossing through pipe. Will need to coordinate with owner to determine additional information about appurtenances found on landward side. (O. Magana - DWR UCIP) FIELD_STRUCT_DESC: Irrigation pump, service pole, and 36-inch concrete standpipe, 5 feet from the landside (LS) toe. No pump was found during field visit 3/20/14. [Additional Reference(s): DWR Levee Logs, 2005] FS Date: 3/20/2014

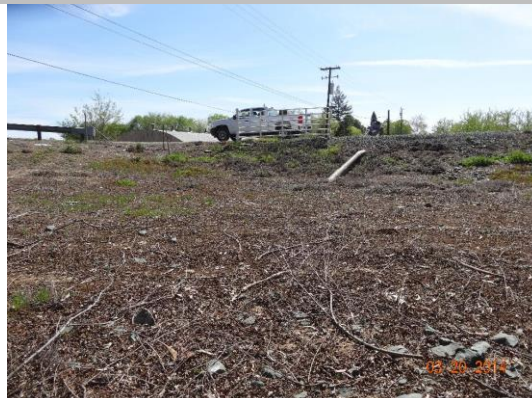
Photo 1 of 3 : UCIP\_FA\_2018\_38331\_69894.jpg

LM Start	2.64	Rating **	M	Issue No.	39
LM End	2.64	Issue Type +	En	Location *	
Category	Supplemental			GPS Latitude/Longitude	
				Start	End
Item	DWR UCIP Field Study			39.031590 °	39.031590 °
				-121.409870 °	-121.409870 °
DWR ID	19477				
Comment Code					
Inspector Comment					
FS_ID:38331 DS_ID:19477 EP_NO: N/A Repair Type: Non-Urgent Crossing Status: Found UCIP Comments: 03/20/2014 Need to contact owner to determine status. (O. Magana - DWR UCIP) FIELD_STRUCT_DESC: 8-inch steel irrigation pipe through the levee, 3.1 feet below the crown. Siphon breaker on the waterward slope. Pump on the landward side. Pipe crosses creek to orchard on north side. (two 12-inch pipes authorized under Permit No. 1887, 1954-H. B. Waltz, HLM 2.41 and 2.68) [Additional Reference(s): DWR Levee Logs, 2005. USACE Sacramento O&M Manual Unit No. 146, November 1962, (HLM 2.68), 8-inch] FS Date: 3/20/2014

View of waterward side.

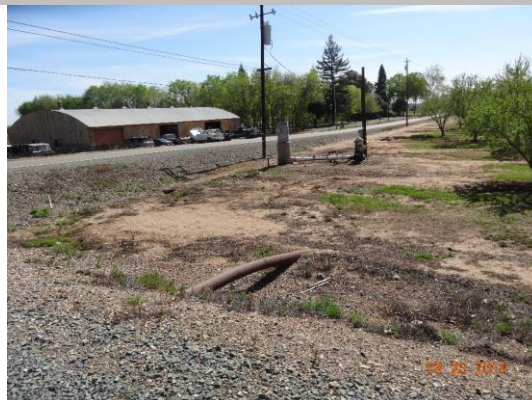
Photo 3 of 3 : UCIP\_FA\_2018\_38331\_69892.jpg

Comment Code						
Inspector Comment						
FS_ID:38331 DS_ID:19477 EP_NO: N/A Repair Type: Non-Urgent Crossing Status: Found UCIP Comments: 03/20/2014 Need to contact owner to determine status. (O. Magana - DWR UCIP) FIELD_STRUCT_DESC: 8-inch steel irrigation pipe through the levee, 3.1 feet below the crown. Siphon breaker on the waterward slope. Pump on the landward side. Pipe crosses creek to orchard on north side. (two 12-inch pipes authorized under Permit No. 1887, 1954-H. B. Waltz, HLM 2.41 and 2.68) [Additional Reference(s): DWR Levee Logs, 2005. USACE Sacramento O&M Manual Unit No. 146, November 1962, (HLM 2.68), 8-inch] FS Date: 3/20/2014

View of landward side.

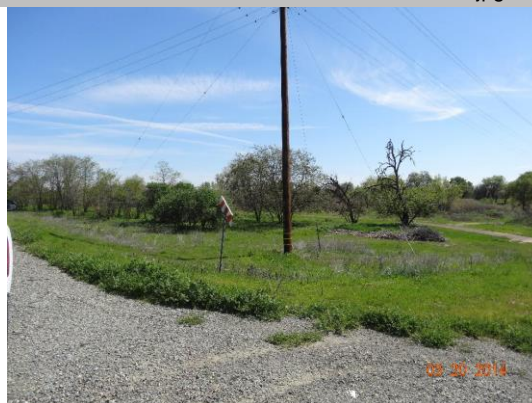
Photo 1 of 3 : UCIP\_FA\_2018\_39994\_69905.jpg

LM Start	1.29	Rating **	M	Issue No.	27	
LM End	1.29	Issue Type +	En	Location *		
Category	Supplemental			GPS Latitude/Longitude		
				Start	End	
Item	DWR UCIP Field Study			38.998322°	38.998322°	
				-121.414688°	-121.414688°	
DWR ID	19509					
Comment Code						
Inspector Comment						
FS_ID:39994						
DS_ID:19509						
EP_NO: N/A						
Repair Type: Non-Urgent						
Crossing Status: Indicator Found						
UCIP Comments: Need to contact owner to determine details of the crossing through levee.						
FIELD_STRUCT_DESC: Wheatland Sewage Disposal Plant on waterward side, treatment plant on landward side. Service pole on waterward slope.						
FS Date: 3/20/2014

View of waterward side.

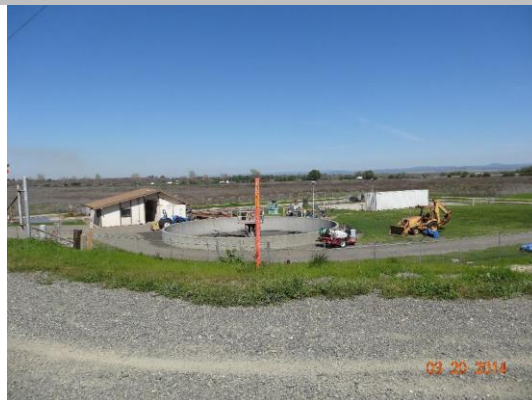
Photo 2 of 3 : UCIP\_FA\_2018\_39994\_69904.jpg

View of water treatment located on landward side, photo 1 of 3.

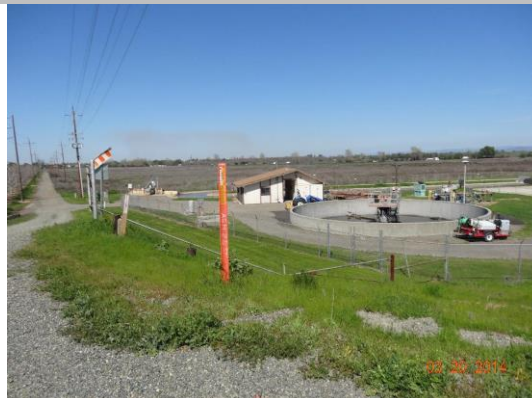
Photo 3 of 3 : UCIP\_FA\_2018\_39994\_69903.jpg

LM Start	1.29	Rating **	M	Issue No.	27 (cont)	
LM End	1.29	Issue Type +	En	Location *		
Category	Supplemental			GPS Latitude/Longitude		
				Start	End	
Item	DWR UCIP Field Study			38.998322°	38.998322°	
				-121.414688°	-121.414688°	
DWR ID	19509					
Comment Code						
Inspector Comment						
FS_ID:39994						
DS_ID:19509						
EP_NO: N/A						
Repair Type: Non-Urgent						
Crossing Status: Indicator Found						
UCIP Comments: Need to contact owner to determine details of the crossing through levee.						
FIELD_STRUCT_DESC: Wheatland Sewage Disposal Plant on waterward side, treatment plant on landward side. Service pole on waterward slope.						
FS Date: 3/20/2014

View of water treatment located on landward side, photo 2 of 3.

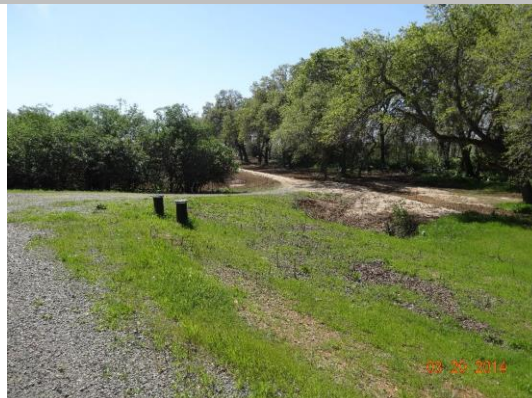
Photo 1 of 3 : UCIP\_FA\_2018\_40045\_71908.jpg

View of waterward shoulder.

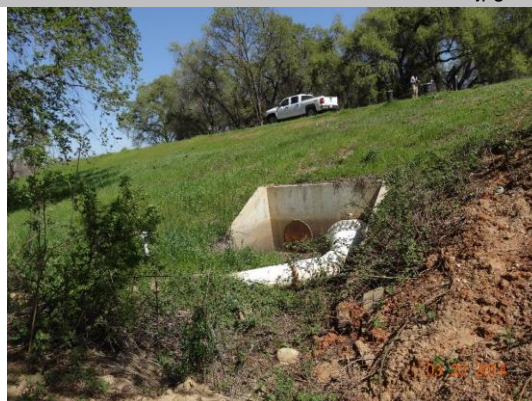
Photo 3 of 3 : UCIP\_FA\_2018\_40045\_71912.jpg

Comment Code						
Inspector Comment						
FS_ID:40045						
DS_ID:19488						
EP_NO: N/A						
Repair Type: Non-Urgent						
Crossing Status: Found						
UCIP Comments: 03/20/2014 Pipe has been plugged--visible on landward side. Need to contact owner to obtain additional information about abandoned crossing. (O. Magana - DWR UCIP)						
FIELD_STRUCT_DESC: 1 of 2: 30-inch corrugated metal irrigation pipe through levee, 13.8 feet below crown. Slide gates in 42-diameter riser on waterside (WS) slope. Concrete "U" headwall at both levee toes. Grouted spillway on landside (LS). [Additional Reference(s): DWR Levee Logs, 2005. USACE Sacramento O&M Manual Unit No. 146, November 1962, (HLM 2.67), two 30-inch]						
FS Date: 3/20/2014

View of waterward side.

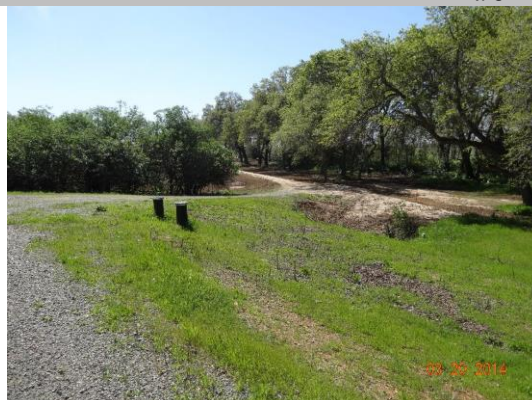
Photo 1 of 3 : UCIP\_FA\_2018\_40046\_71915.jpg

Comment Code					
Inspector Comment					
FS_ID:40046 DS_ID:19504 EP_NO: N/A Repair Type: Non-Urgent Crossing Status: Found UCIP Comments: 03/20/2014 Need to contact owner to determine status--crossing appears to be modified. Need to contact owner to obtain additional information about modified crossing. (O. Magana - DWR UCIP) FIELD_STRUCT_DESC: 2 of 2: 30-inch corrugated metal irrigation pipe through levee, 13.8 feet below crown. Slide gates in 42-diameter riser on waterside (WS) slope. Concrete "U" headwall at both levee toes. Grouted spillway on landside (LS). [Additional Reference(s): DWR Levee Logs, 2005. USACE Sacramento O&M Manual Unit No. 146, November 1962, (HLM 2.67), two 30-inch] FS Date: 3/20/2014

View of waterward side.

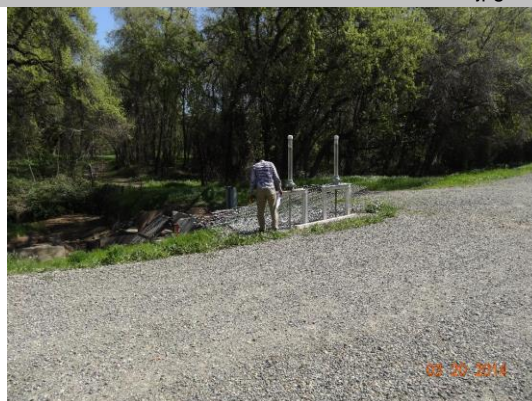
Photo 2 of 3 : UCIP\_FA\_2018\_40046\_71914.jpg

View of landward side.

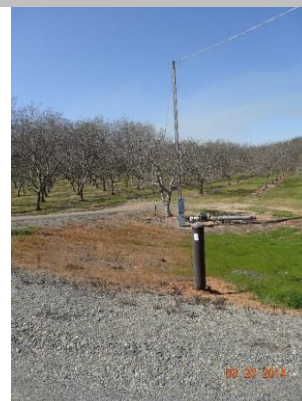
Photo 1 of 3 : UCIP\_FA\_2018\_40048\_71922.jpg

View of waterward side.

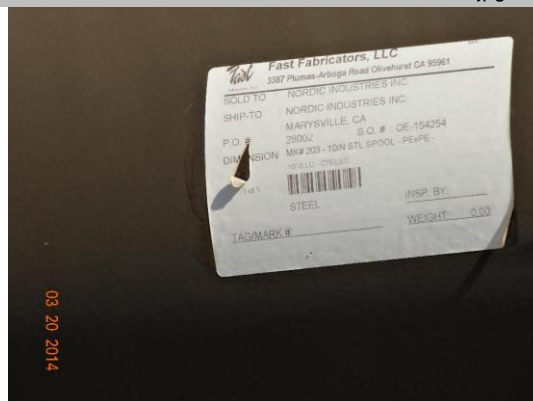
Photo 3 of 3 : UCIP\_FA\_2018\_40048\_71920.jpg

Label on riser.

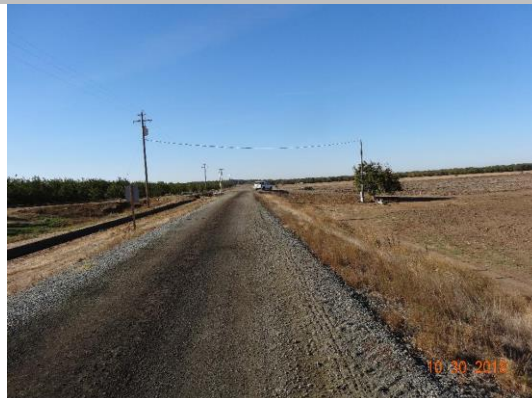
Photo 1 of 2 : UCIP\_FA\_2018\_53438\_78444.jpg

Overview of levee where crossing should be. No signs of crossing present.

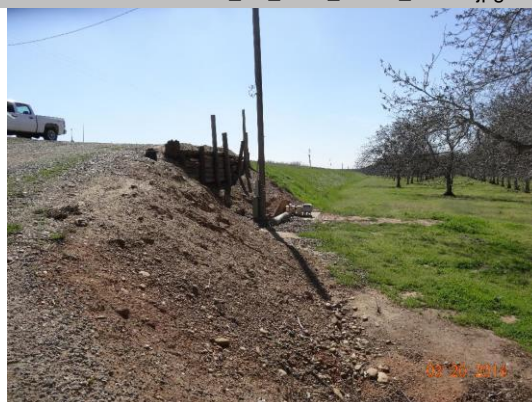
Photo 2 of 3 : UCIP\_FA\_2018\_40049\_71926.jpg

Overview of waterward side.
